Manhole Inspection Summary

Manhole # S13EE1020MH

Insp Date: **1/26/09 2:09 PM**

Location Address: **REAR 3940 PARK HEIGHTS AVE**

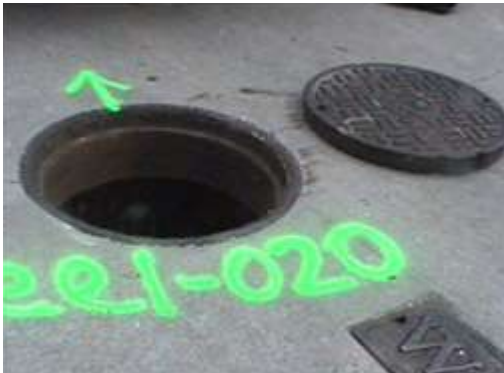
Location View

LOOSE BRICKS AND DETERIORATION

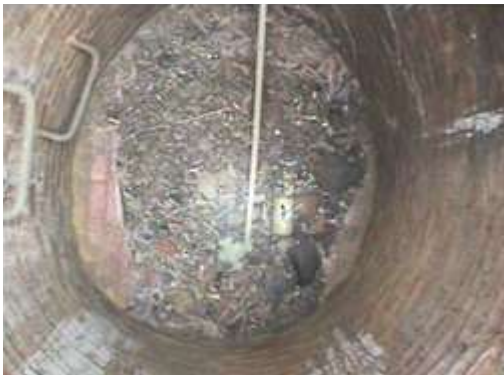
Top View

CHANNEL DEBRIS

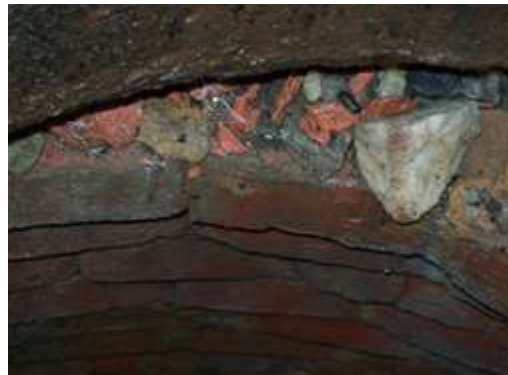
Defect 2

Condition: ☐ Sound ☐ Cracked ☐ Root Intrusion ☒ **Loose Brick** ☒ **Deteriorated**

LOOSE BRICKS AND DETERIORATION

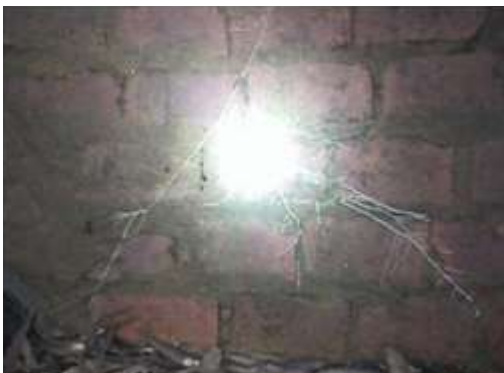
Defect 1

Condition: ☐ Sound ☐ Cracked ☒ **Root Intrusion** ☐ Loose Brick ☐ Deteriorated

Infiltration: ☐ None ☐ Joint ☐ Cracks ☐ Mortar ☒ **Roots** ☐ Wall

ROOT INFILTRATION- FINE

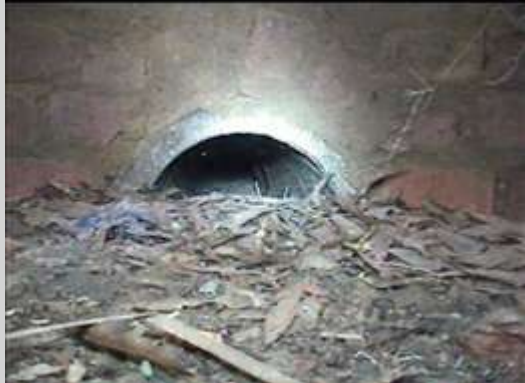
12 O'Clock Outflow

8 in. Circular Gravity Sewer
Pipe Out @ 12 O'Clock

Deposits: ☐ None ☐ Mud ☐ Sludge ☒ **Debris** ☐ Grease

Silt Depth: **5** (in.) Deposits Extent: **Heavy**
